**Re: Limited IAQ Assessment**  
Nantucket High School  
10 Surfside Road  
Nantucket, MA 02554  
**VERTEX Project No. 92963**

The Vertex Companies, LLC (VERTEX) is pleased to provide this letter report pertaining to the Limited Indoor Air Quality (IAQ) Assessment conducted by VERTEX within the Nantucket High School located in Nantucket, MA (herein referred to as the "Site").

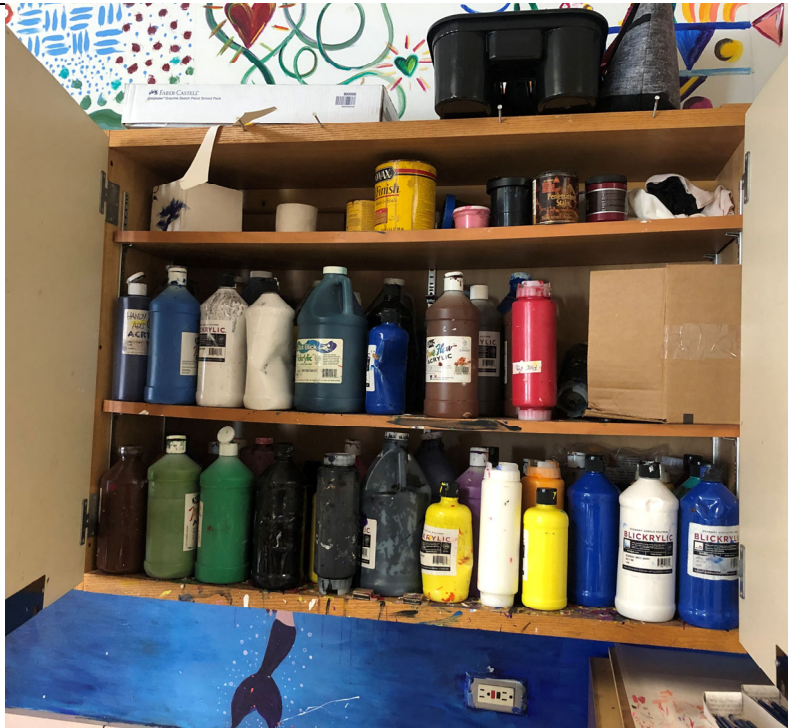
#### Photograph: 1

- Water-Based Acrylic Paint and Oil-Based Paint storage in the classroom cabinets within the lower-level Art Room. No concerns were noted regarding storage of the paint. (See Photo 1 and Photo 2).

Photograph depicts general view of Paint Storage in the lower Level Art Room.

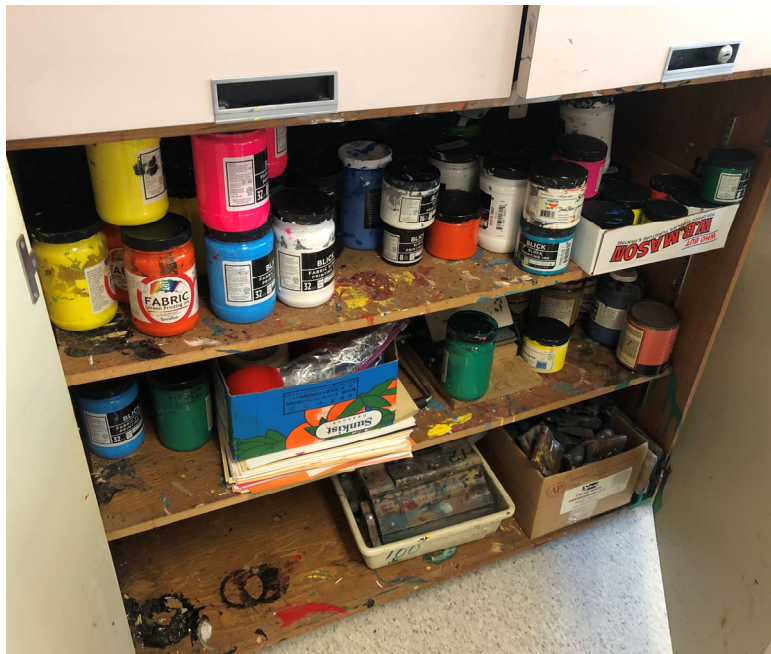
#### Photograph: 2

Photograph depicts general view of Paint Storage in the lower Level Art Room.

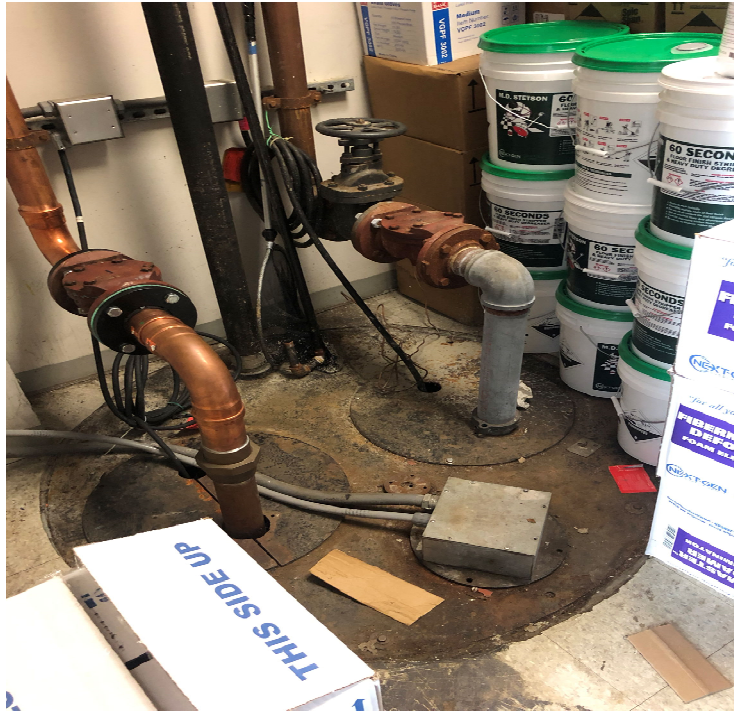
#### Photograph: 3

- Ejector pit area observed in Room 015 within the lower level at the school. Ejector pit was observed to be properly covered (See Photo 3).
- Water staining was observed on several ceiling tiles within the main office area. (See Photo 4). In addition, suspect mold growth was observed on one of water-stained ceiling tile(See Photo 4). Further inspection above the drop ceiling tiles did not indicate active leaks in plumbing or the roof. Uninsulated mechanical duct work was observed directly above the water-stained ceiling tiles. (See Photo 5).

Photograph depicts general view of Ejector Pump within Room 015.

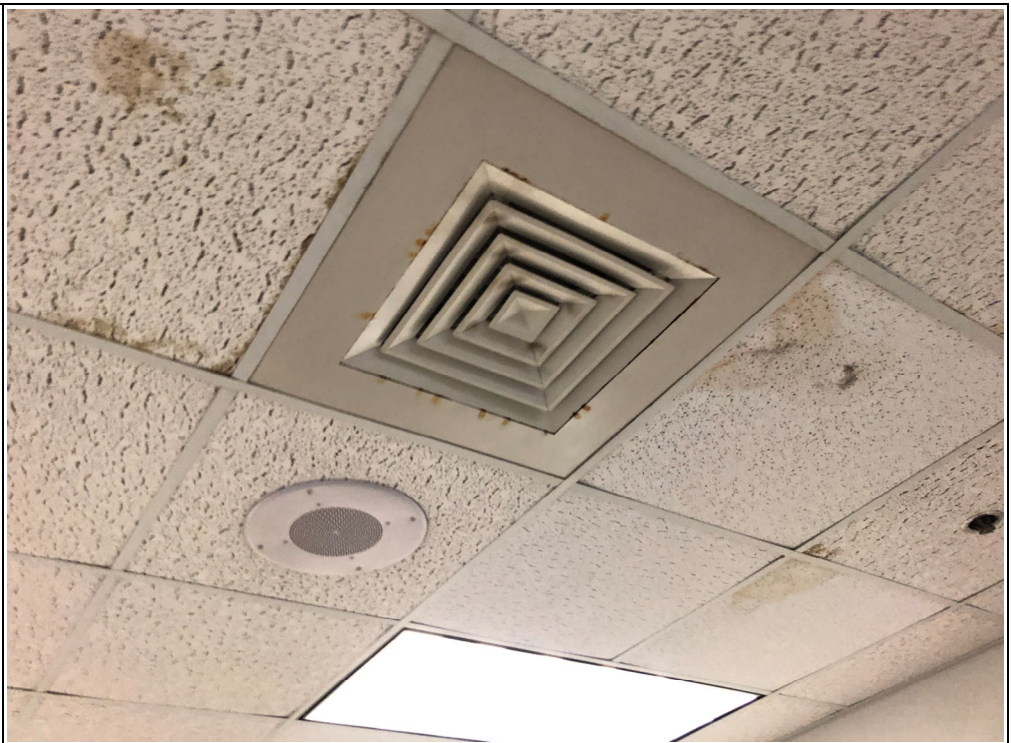
#### Photograph: 4

- Water staining was observed on several ceiling tiles within the main office area. In addition, suspect mold growth was observed on one of water-stained ceiling tile(See Photo 4). Further inspection above the drop ceiling tiles did not indicate active leaks in plumbing or the roof. Uninsulated mechanical duct work may sweat during cooling season which has resulted the water-stained ceiling tiles directly below.

Photograph depicts general view of water stained ceiling tiles and suspect visible mold growth within the Main Office Area.

- Remove and replace water-stained ceiling tiles within the Main Office Area and Room 201.
- Ensure that all supply diffusers and return air grills and covers are cleaned on a regular basis such that they are free of dust, debris, or obstructions.
- Increase fresh air intake and ventilation within Rooms 006, 102, 106 and 201 when occupied.
- Inspect and repair, if needed, the roof top ventilation system that serves Rooms 106A and 208 to prevent potential future water intrusion events.

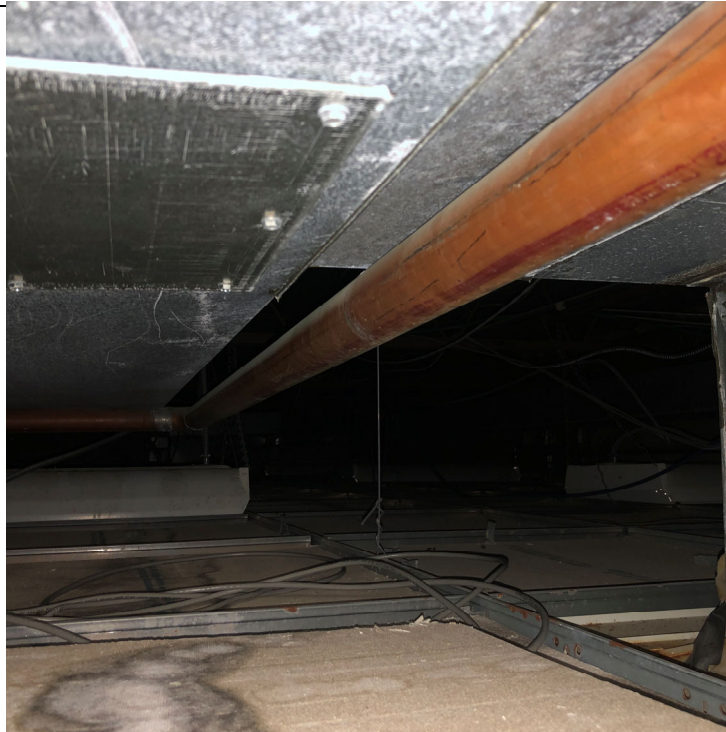
Photograph depicts general view of uninsulated mechanical duct and visible suspect mold growth above the water stained ceiling tile area within the Main Office area.

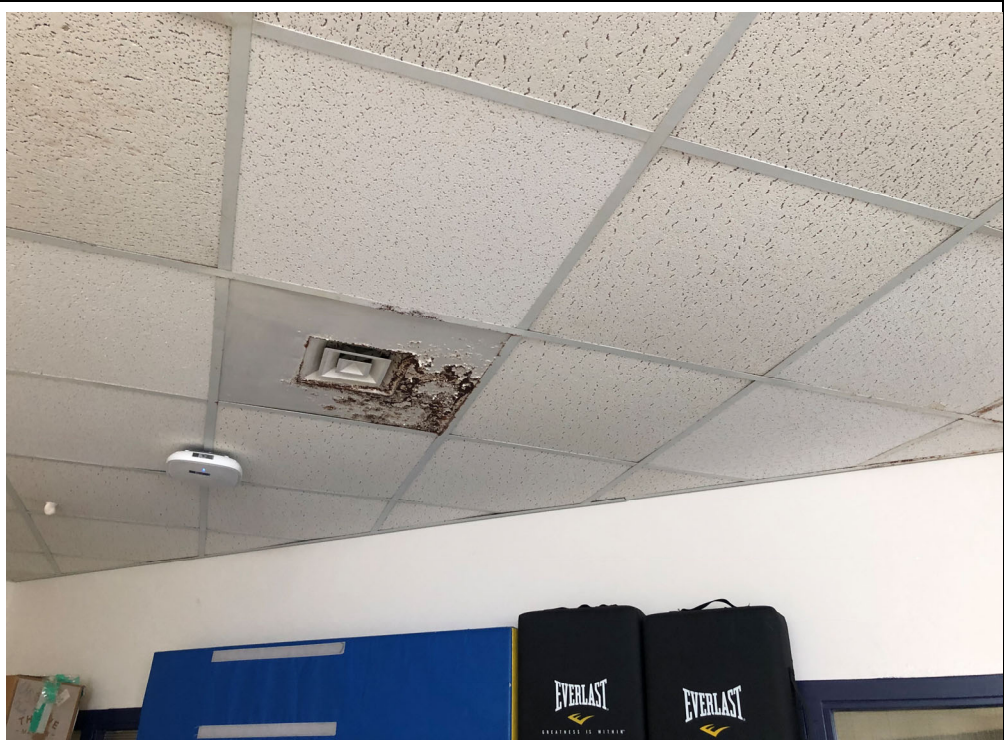
- Heavy oxidation(rust) /water damage was observed on a ventilation register within Room 106A. (See Photo 6).
- Water staining was observed on two ceiling tiles within the Room 201 (See Photo 7). Further inspection above the drop ceiling tiles did not indicate active leaks in plumbing or the roof (See Photo 7). According to the site contact, there appears to be a roof leak that can not be located on the roof area and water intrusion events only are observed during heavy wind driven rain events.

- Heavy oxidation(rust) /water damage was observed on a ventilation register within Rooms 106A and 208. This may be due to wind driven rain events which may cause water intrusion into the ventilation system resulting in the observed conditions.

Photograph depicts general view of the heavy oxidation on the ventilation register within Room 106A.

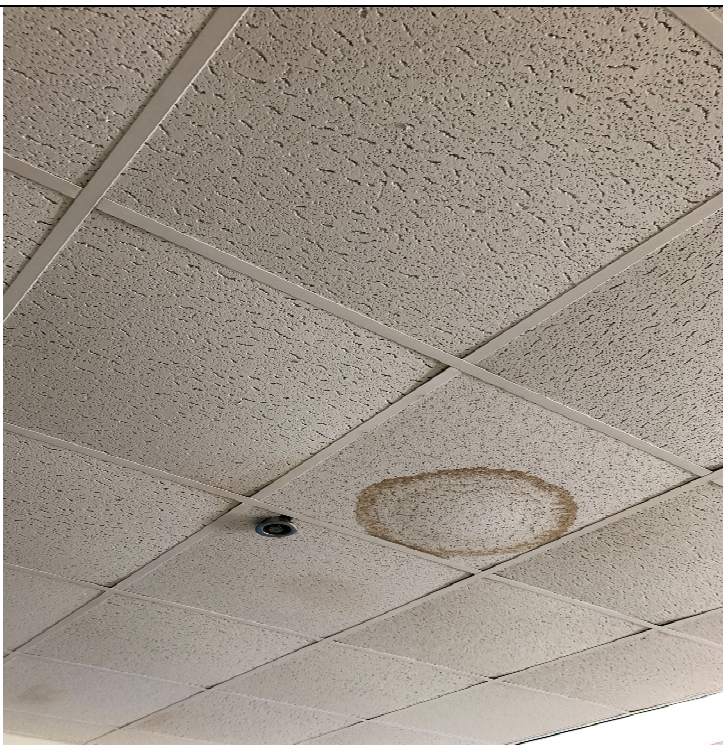
- Water staining was observed on two ceiling tiles within Room 201 (See Photo 7). Further inspection above the drop ceiling tiles did not indicate active leaks in plumbing or the roof (See Photo 7). According to the site contact, there appears to be a roof leak that can not be located on the roof area and water intrusion events are only observed during heavy wind driven rain events.

Photograph depicts general view of the water-stained ceiling tiles within Room 201.

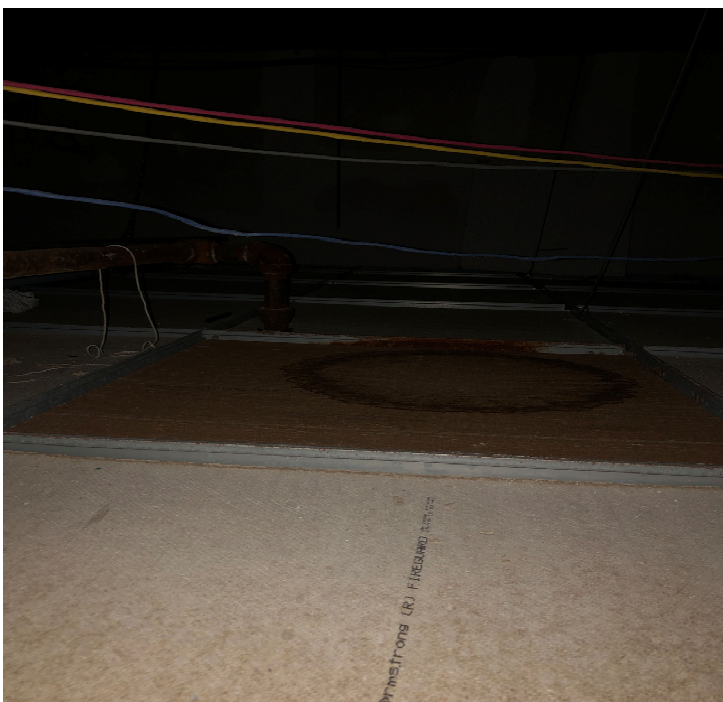
Photograph depicts general view of area above water-stained ceiling tile within Room 201.

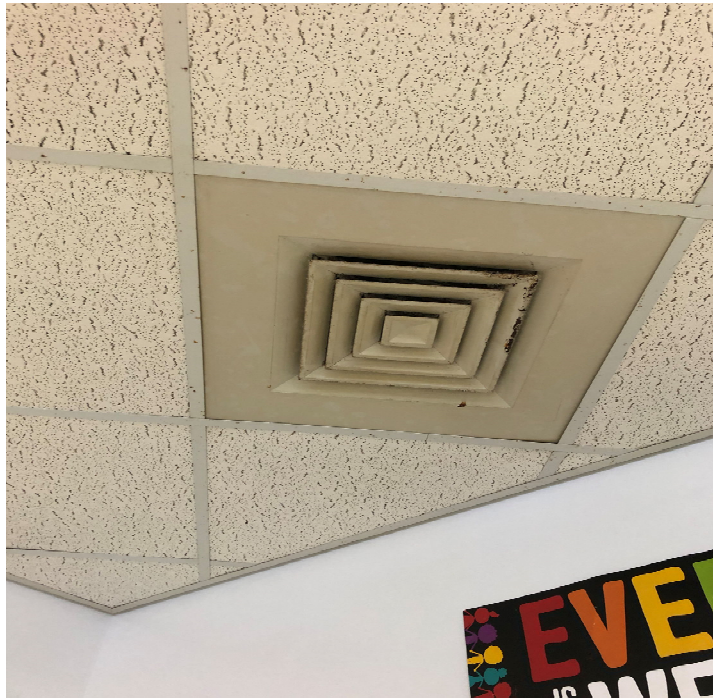
### Photograph: 10

- Particulate accumulation was observed on a ventilation register within Room 204 (See Photo 9).
- Heavy oxidation(rust) /water damage was observed on a ventilation register within Room 208. (See Photo 10).

Photograph depicts general view of the oxidation on the ventilation register within Room 208.

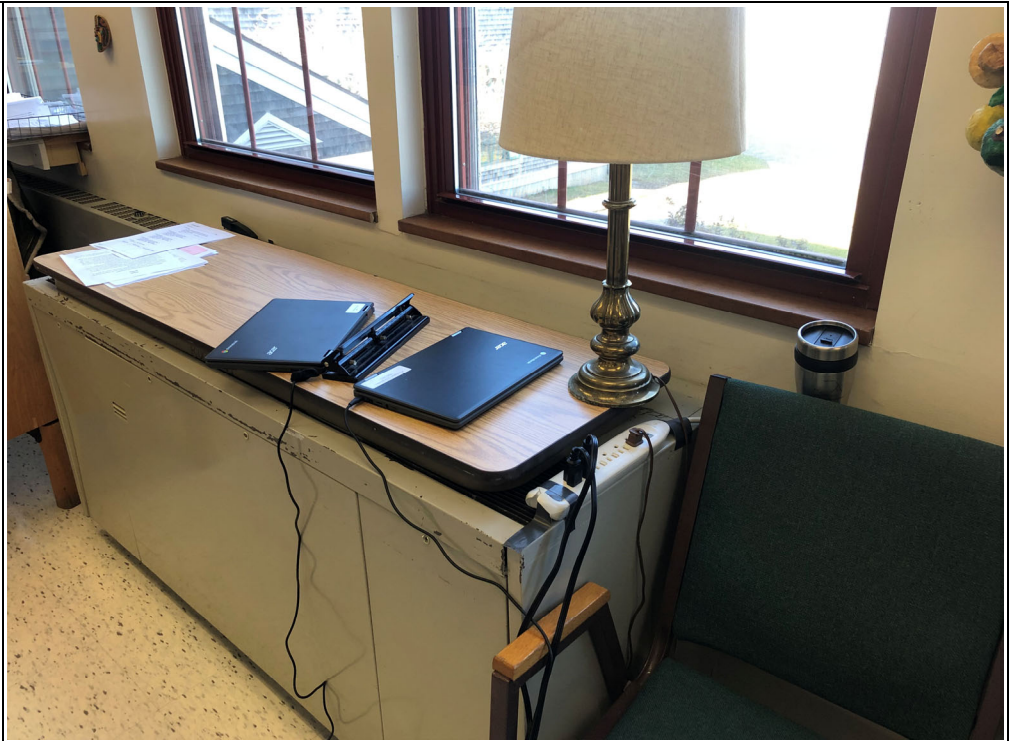
#### Photograph: 11

- Unit-vent supply blocked with foldable table within Room 213 (See Photo 11).
- Areas of suspect visible mold growth throughout the remainder of the school was not observed at the time of assessment.

- Particulate accumulation was observed on a ventilation register within Room 204.
- Unit-vent supply blocked with foldable table within Room 213.

Photograph depicts general view of folding table on and restricting uninvent air supply.

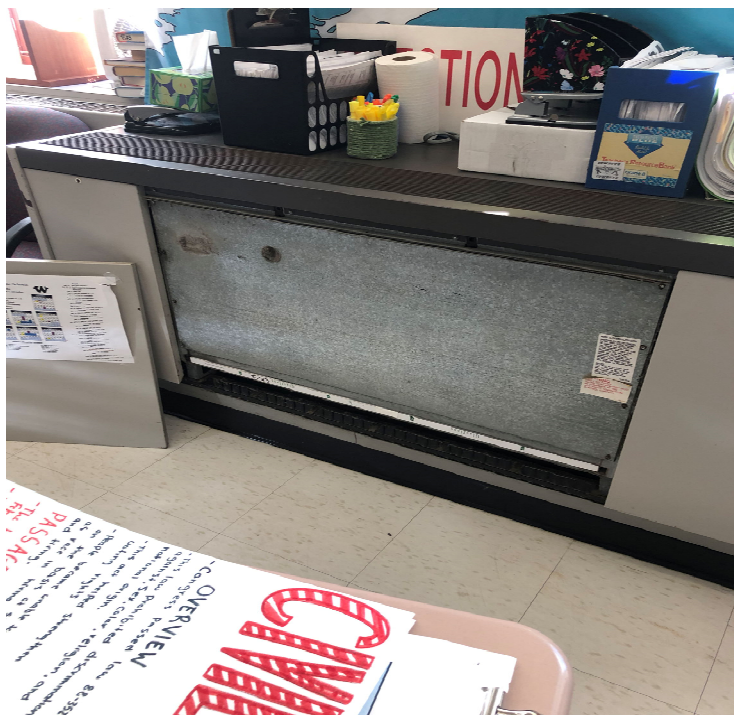
#### Photograph: 12

- Inspection of the filters within the wall mounted uninvents indicated a Merv-10 rating and were dated September 2023 (See Photo 12, 13 and 14).

Photograph depicts general view of typical classroom uninvent.

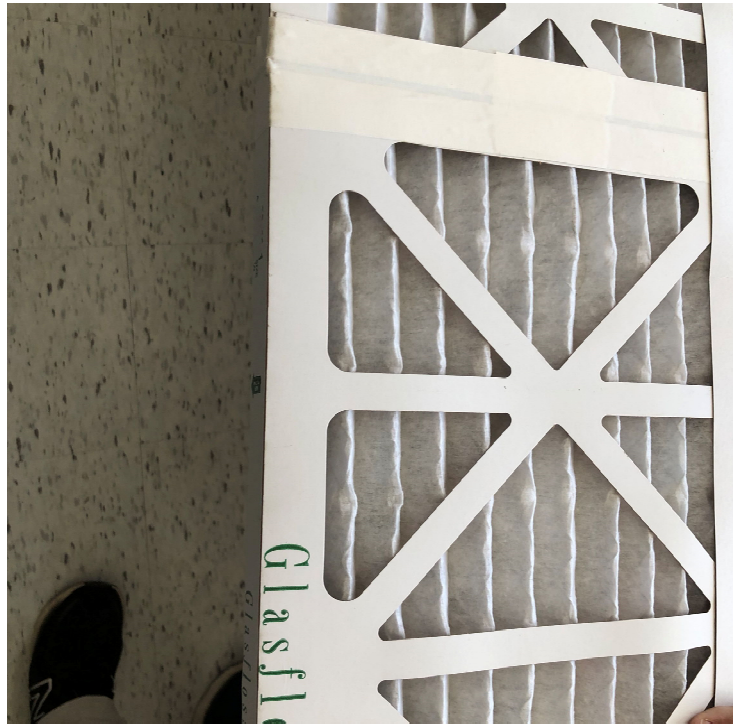
#### Photograph: 13

Photograph depicts general view of the condition of the typical filter for the unit-ventilator.

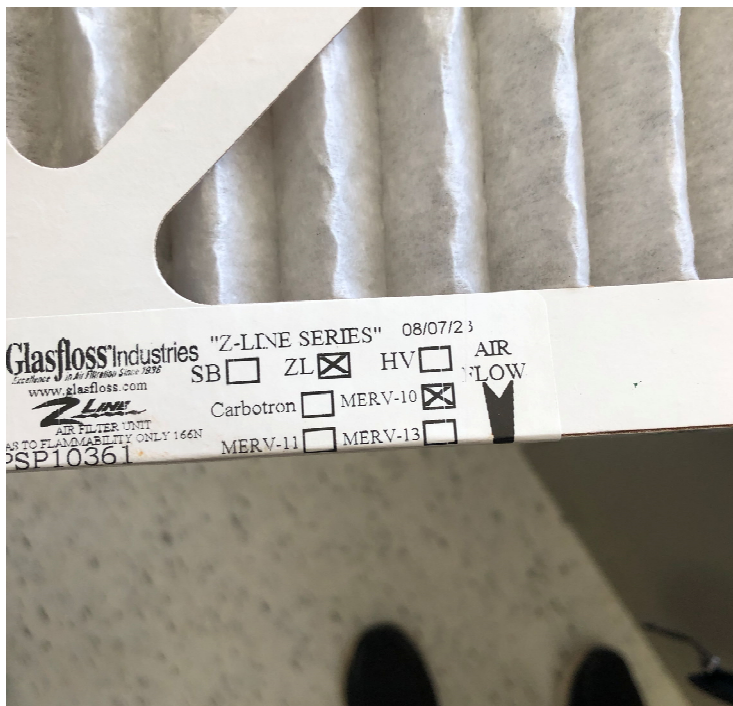
#### Photograph: 14

Photograph depicts general view of typical filter specifications.
